December 1999

# GEOTECHNICAL NEWS

## FRP Composite Polymer Piling: An Alternative to Timber Piling for Water-Front Applications

Magued G. Iskander and Anna Stachula

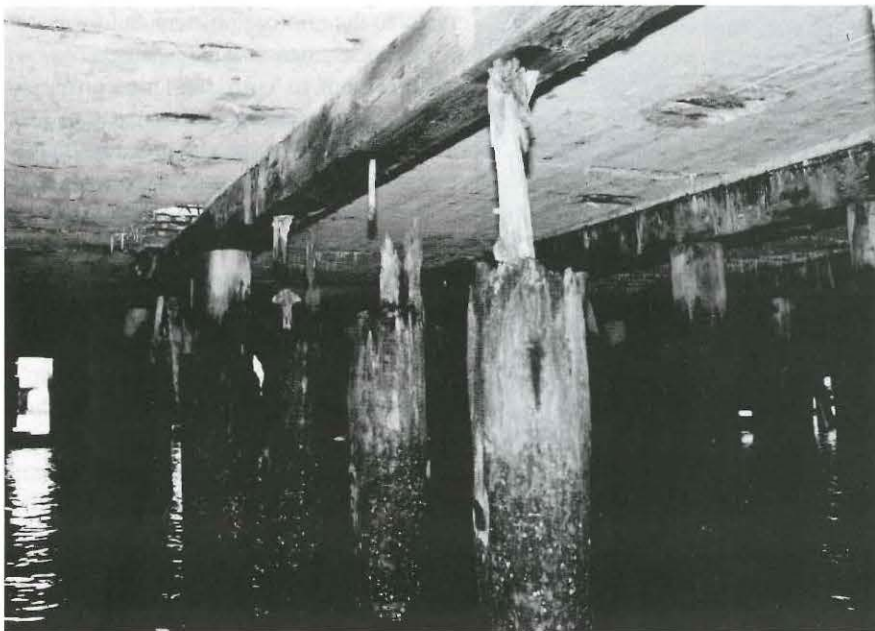
*Figure 1. Marine borers (Limnoria) attacking untreated timber piles which support many of New York's pile supported highways and harbor piers.*

*The deterioration of timber, concrete, and steel piling systems costs the United States nearly \$1 billion per year for repair and replacement (Lampo et al. 1998). The durability of concrete and corrosion of steel are serious hindrances to water-front construction. In the case of timber piling, the Federal Water Pollution Control Act of 1972 gradually rejuvenated many of the nations water ways and harbors. With the return of the marine life, tiny marine borers started attacking the untreated timber piles which support many of the nations harbor piers (Fig. 1).*

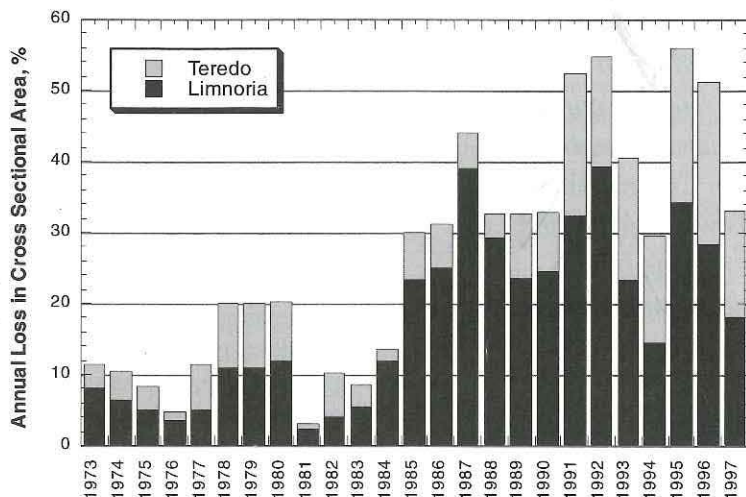
Figure 2. Average intensity of marine borers attack on untreated timber in 32 sites monitored by The Port Authority of New York & New Jersey (After Bognacki & Gill, 1997).

**Timber:** Prior to the clean water act of 1972, marine borers could not exist due to pollution. One trade-off to this environmental benefit is a significant increase in the amount of marine borer activity in coastal waters, resulting in

widespread damage to marine timber infrastructures (Fig. 2). *Teredo*, *bankia*, and *limnoria* are the three most common and destructive borers. *Teredo* and *bankia* (ship-worms) enter the wood as a larva and follow the grain, tunneling

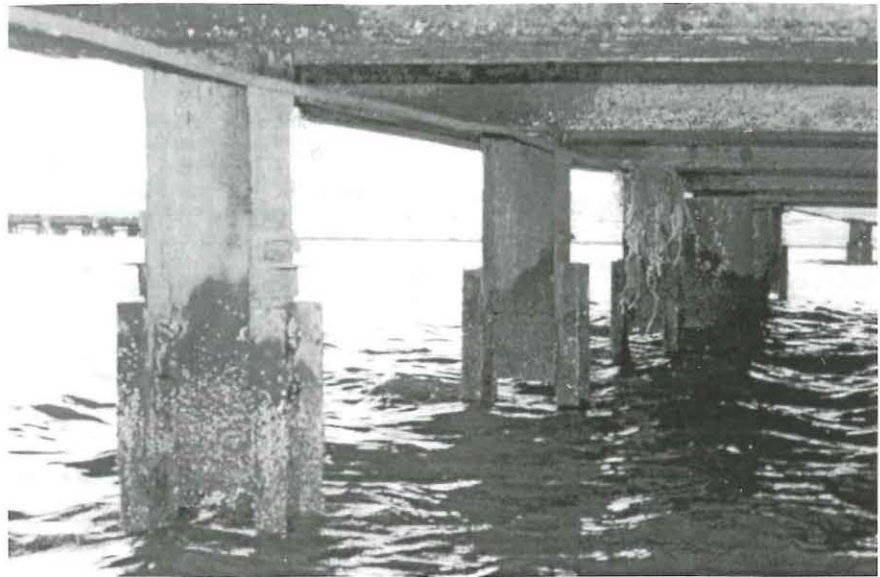
Fig. 4. Complete corrosion of steel H piles supporting a harbor pier. Note that recently installed retrofit channels are already corroding.

**Steel:** The major cause of deterioration of steel piles is corrosion, especially in industrial and marine environments (Fig. 4). The rate of corrosion in regular soils is approximately 0.03 mm per year; it increases to 1.2 mm per year in the splash zone (Fleming *et al.*, 1992). Corrosion of the steel piles can be prevented by coatings containing heavy metals, but these treatments are harmful to the environment.

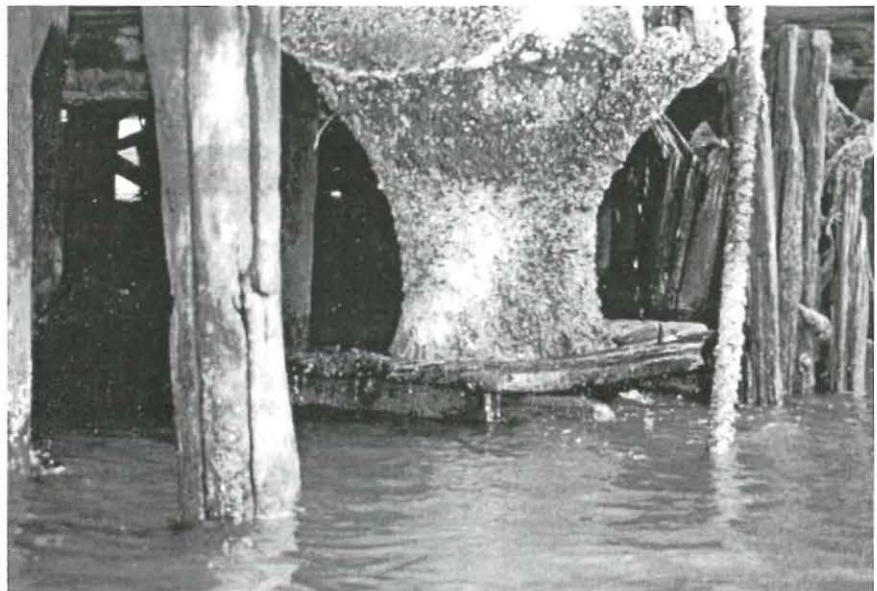
Figure 5. Deterioration of reinforced concrete piling supporting a harbor pier, causing it to lose 65% of its cross sectional area.

**Concrete:** The most destructive agents for reinforced concrete piles are sodium and calcium chlorides. These salts penetrate through the concrete cracks to the reinforcing steel and form an electrical current which causes the reinforcement to corrode. This corrosion process is accompanied by expansion, which tends to induce high tensile stresses in the surrounding concrete causing cracking and spalling (Fig. 5). In marine environments, in addition to salts, the variation of temperature, freezing and thawing, further degrades the concrete.

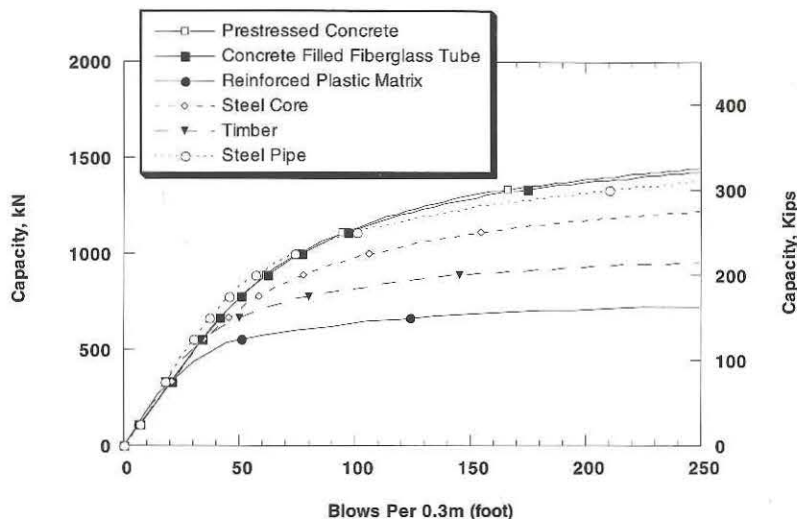
Figure 7. Bearing graphs of 12 m (40 ft.) long piles driven 10.7 m (35 ft.) in sand.

Theoretical driveability studies show that composite piling could be driven to reasonable capacities for load bearing (Fig. 7). These studies indicate that the drive-ability of conventional piling is mostly influenced by the soil parameters, while the drive-ability of softer polymeric sections depends mostly on the specific weight and elastic modulus of the pile material (Stachula, 1999).
