# **Recent Developments in FRP Composite Piling Practice**

**TRB 2002 Session on Composite Piles (Committee A2K03)**

(Paper No: 02-3589)

Magued G. Iskander, PhD, PE

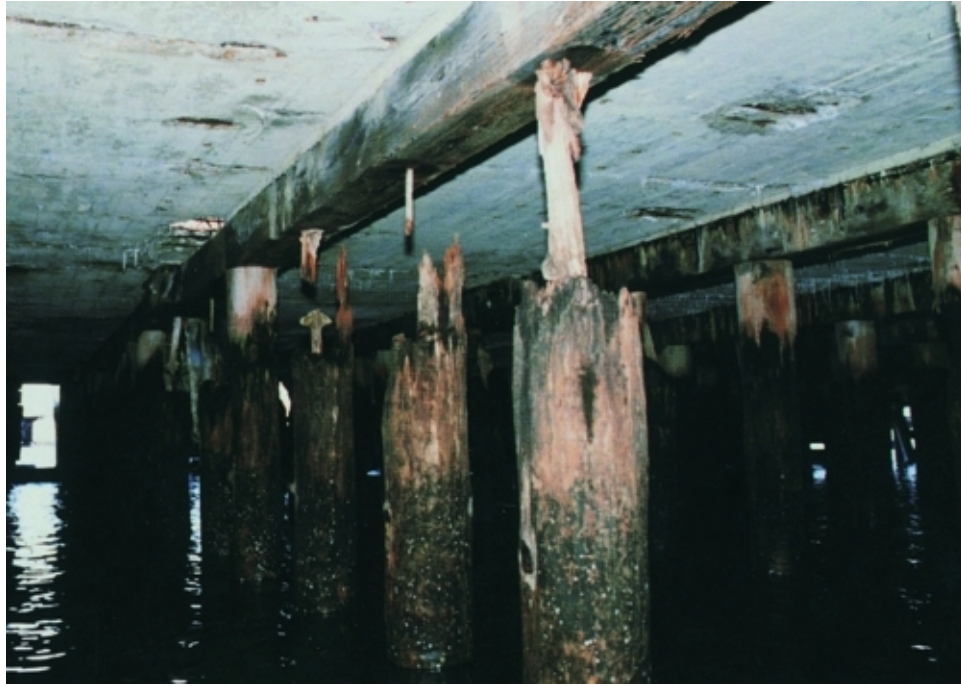
**Fig. 1 Marine Borers (Limnoria) Attacking Untreated Timber Piles Which Support Many of New York's Pile Supported Highways and Harbor Piers.**

Prior to the clean water act of 1972, marine borers could not exist due to pollution. One trade-off to this environmental benefit is a significant increase in marine borer activity in coastal waters, resulting in widespread damage to marine timber infrastructures (Fig. 2). Teredo, Bankia, and Limnoria are the three most common and destructive borers. Teredo and Bankia (ship-worms) enter the wood as a larva and follow the grain, tunneling deeper as the worm grows. Numerous tunneling in a timber pile make the wood's interior as holed as Swiss cheese (Fig. 3). Limnoria nibble at the outside edges of the timber piles causing timber piling to lose up to 1 inch in diameter yearly (Fig. 1). The most effective method of reducing marine borer attack is the pressure treatment with creosote and arsenate. However, treatment doesn't stop borers from attacking the wood completely.

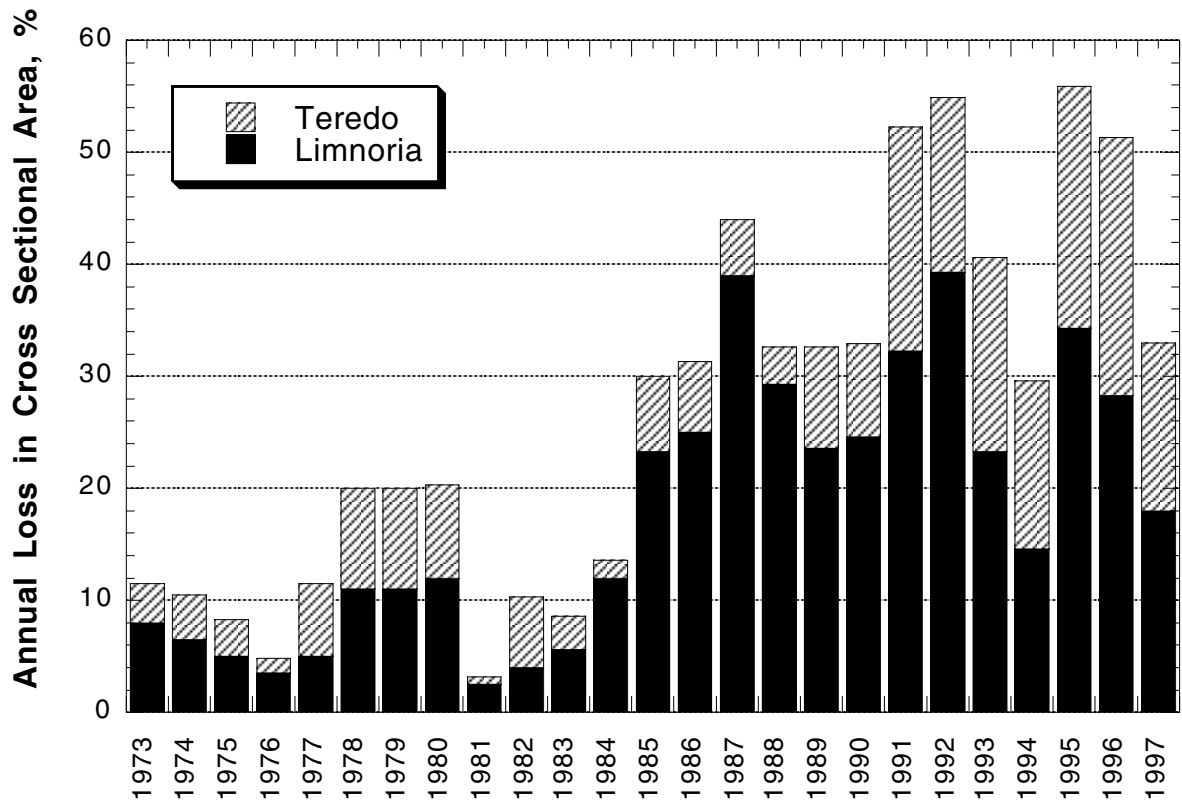
**Fig. 2 Average Intensity of Marine Borers Attack on Untreated Timber in 32 Sites Monitored by The Port Authority of New York & New Jersey (After Bognacki & Gill, 1997)**

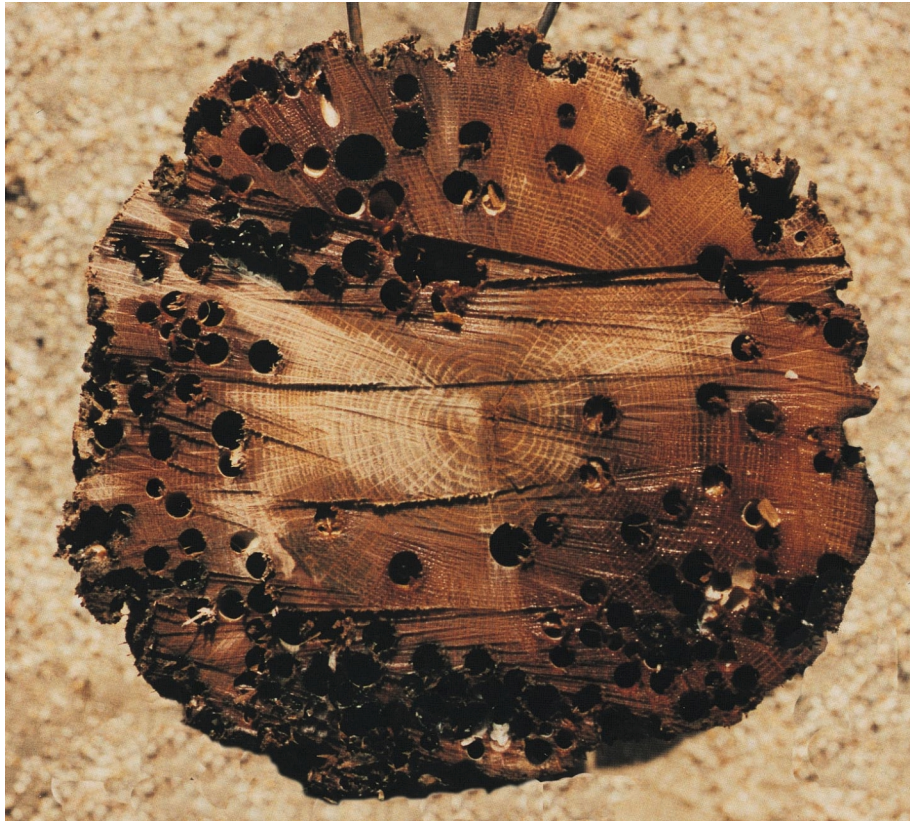
**Fig. 3 Numerous Ship-worms (Teredo and Bankia) Tunneling in A Timber Pile Make The Wood's Interior as Holed as Swiss Cheese.**

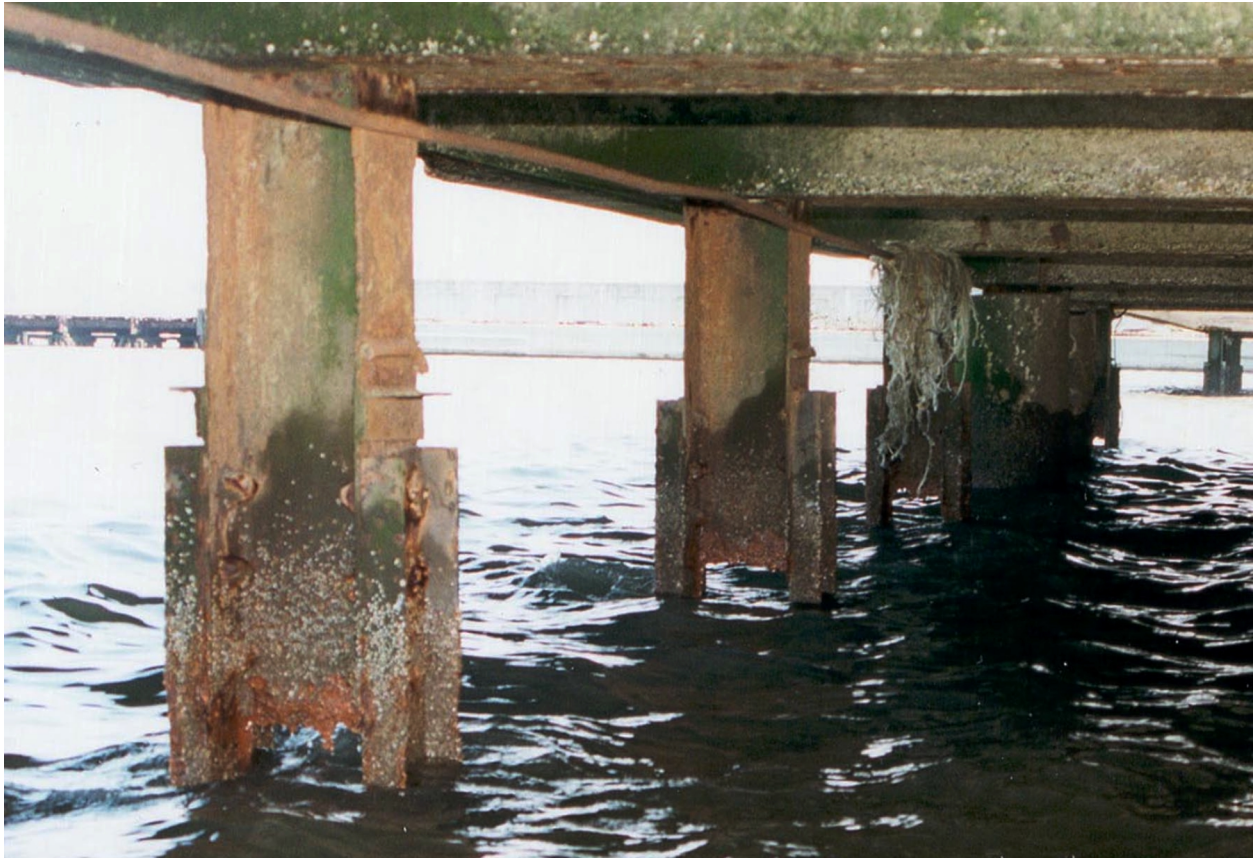
**Fig. 4 Complete Corrosion of Steel H Piles Supporting A Harbor Pier. Note That Recently Installed Retrofit Channels are Already Corroding**

The major cause of deterioration of steel piles is corrosion, especially in industrial and marine environments (Fig. 4). The rate of corrosion in regular soils is approximately 0.03 mm per year; it increases to 1.2 mm per year in the splash zone (11). Corrosion of the steel piles can be prevented by coatings containing heavy metals, but these treatments are harmful to the environment.

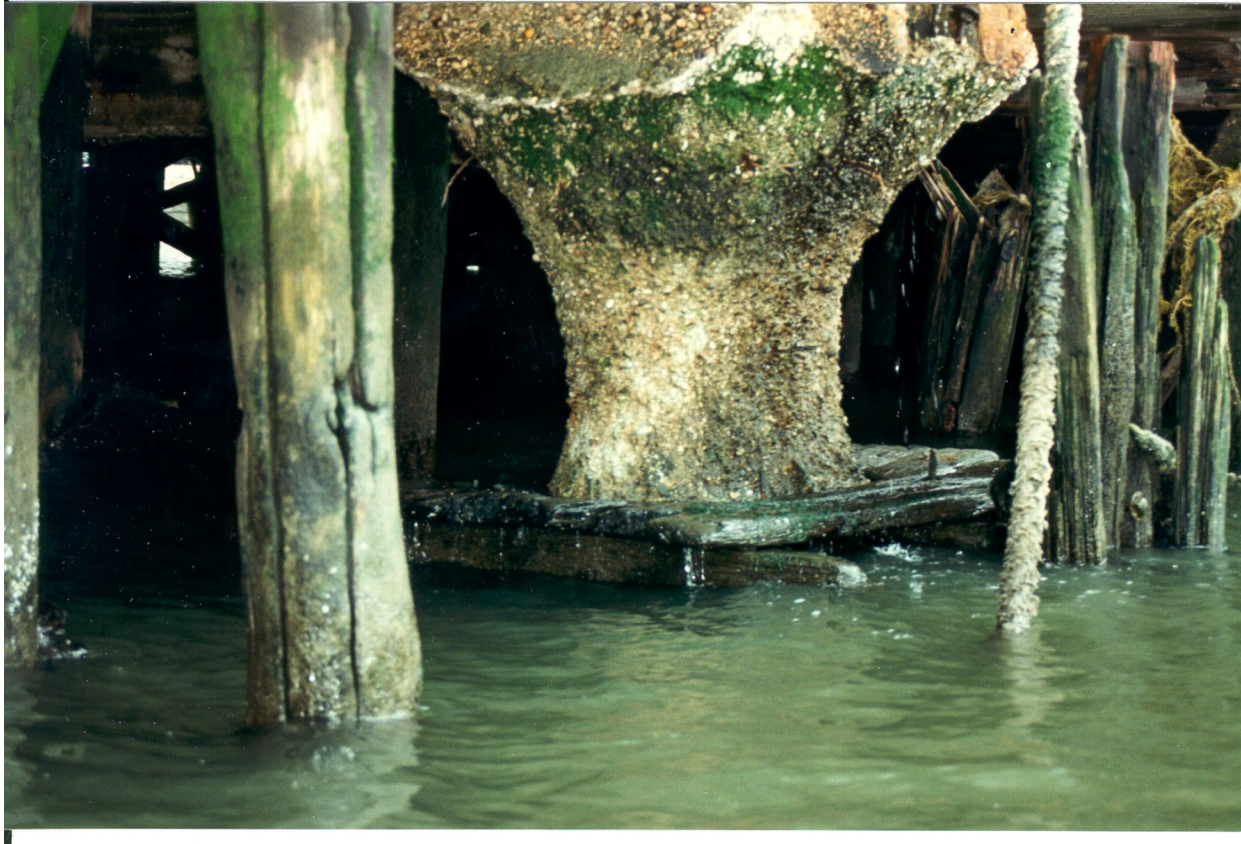
**Fig. 5 Deterioration of Reinforced Concrete Piling Supporting a Harbor Pier, Causing it to Lose 65% of its Cross Sectional Area.**

The most destructive agents for reinforced concrete piles are sodium and calcium chlorides. These salts penetrate through the concrete cracks to the reinforcing steel and form an electrical current, which causes the reinforcement to corrode. This corrosion process is accompanied by expansion, which tends to induce high tensile stresses in the surrounding concrete causing cracking and spalling (Fig. 5). In marine environments, in addition to salts, the variation of temperature, freezing and thawing, further degrades the concrete.

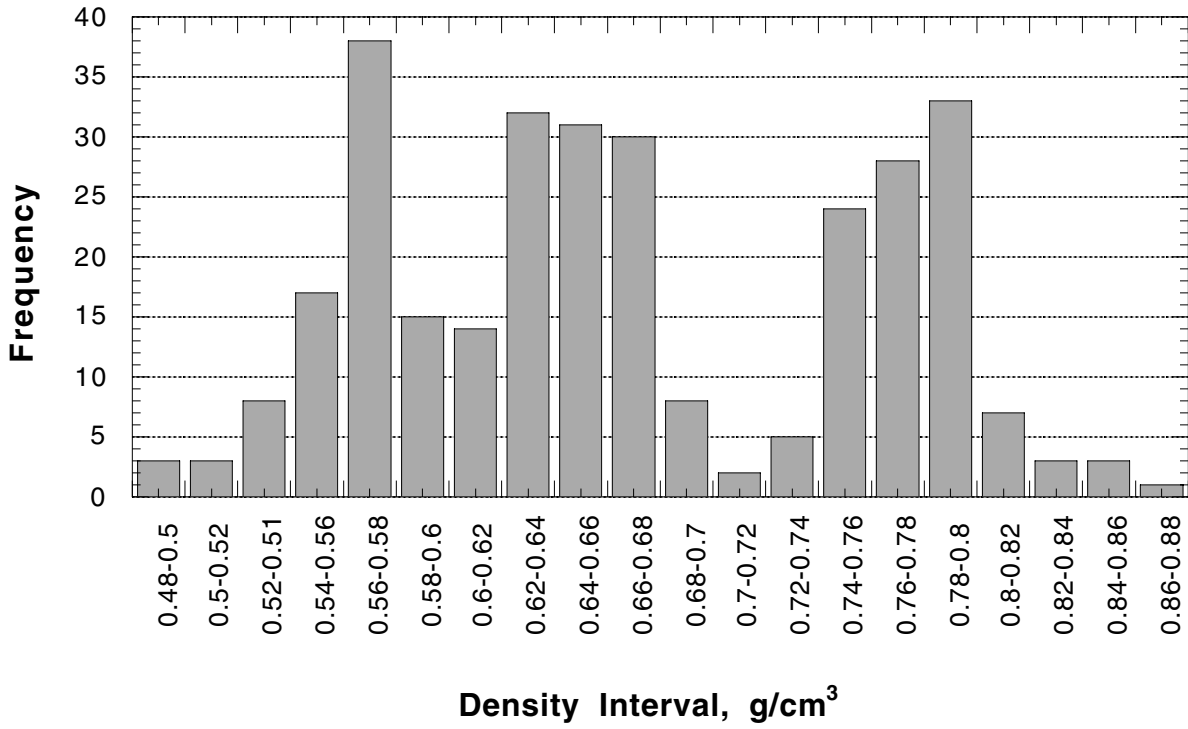
**Fig. 7 Density Distribution of Tested Specimens**

The physical and engineering properties of most polymeric piling typically exhibit a high coefficient of variation, particularly when recycled plastics are used (18). For example, the unit weights of specimens taken from a Seapile™ reinforced plastic pile made by Seaward International are shown in Fig. 7. This difference in densities is caused by the manufacturing procedure of Seapile™. Seapile™, like many polymeric structural members is foamed at the center and solid at the edges. In addition, the manufacturing process could have resulted in variation in strength of the parent material across the cross section.

When the stress vs. strain data of the specimens shown in Fig. 7 were first plotted, a large scatter was observed (Fig. 8) even though the specimens came from the same pile. Several methods to normalize the data and reduce scatter were investigated (18). The non-dimensional term  $\sigma/\gamma R$  was found to reduce scatter the most (Fig. 9). Where  $\sigma$  is the measured stress,  $\gamma$  is the density of the specimen, and  $R$  is the radial distance from the center of the core to the location of the specimen. The term  $\sigma/\gamma R$  is referred to as the *Characteristic Stress*, and is believed to be a unique signature property for foamed structural members. In any case, better definition of performance can be achieved if appropriate quality control measures are implemented.

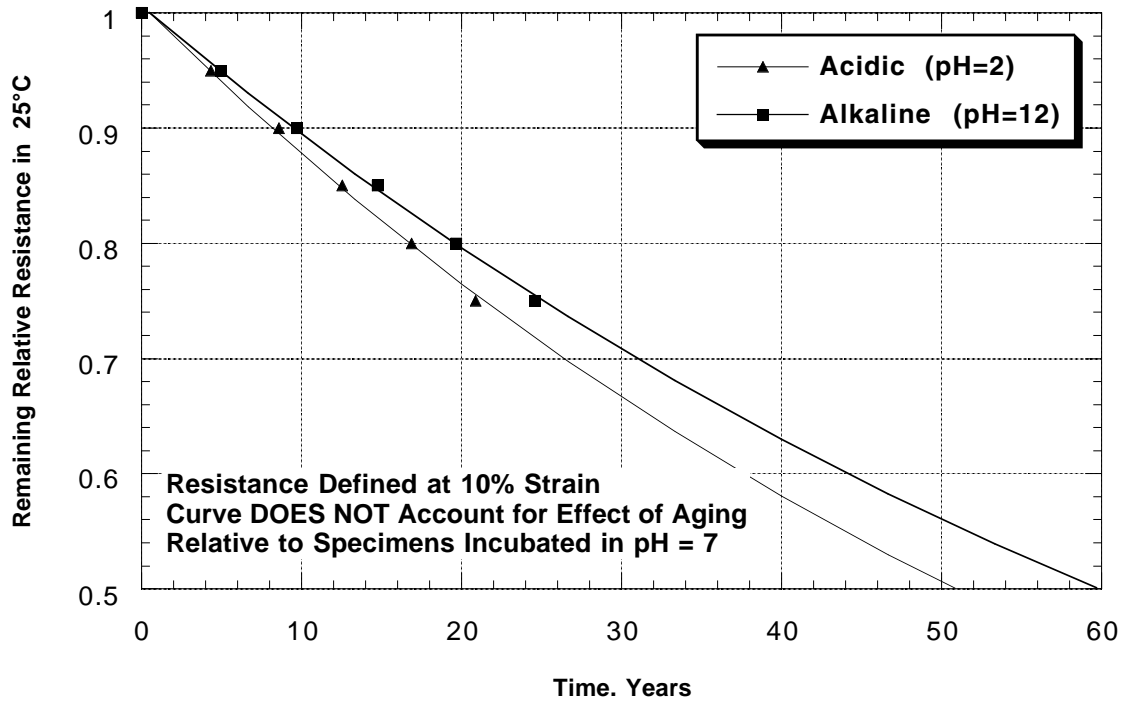
**Fig. 10 Remaining Relative Resistance at 10% strain in Room Temperature**

Exposure to the acidic environment (pH =2) and alkaline environment (pH = 12) had a consistent measurable degradative effect on recycled HDPE (Fig. 10). An estimated 25% loss in resistance at 10% strain, is projected to take 21 years for coupon specimens incubated at pH = 2 and 25 years for coupon specimens incubated at pH = 12. If the reaction rates remain constant, 50–60 years are required for a 50% loss in relative compressive strength of coupon specimens under the same conditions. These projected remaining resistances are relative to specimens incubated in water and ignore the effect of aging on the mechanical properties of polymers. These results represent a lower bound because the study was conducted on coupon specimens, which were exposed to aggressive media at the surface. Piling is typically 25-40 times larger in diameter than the tested specimens.

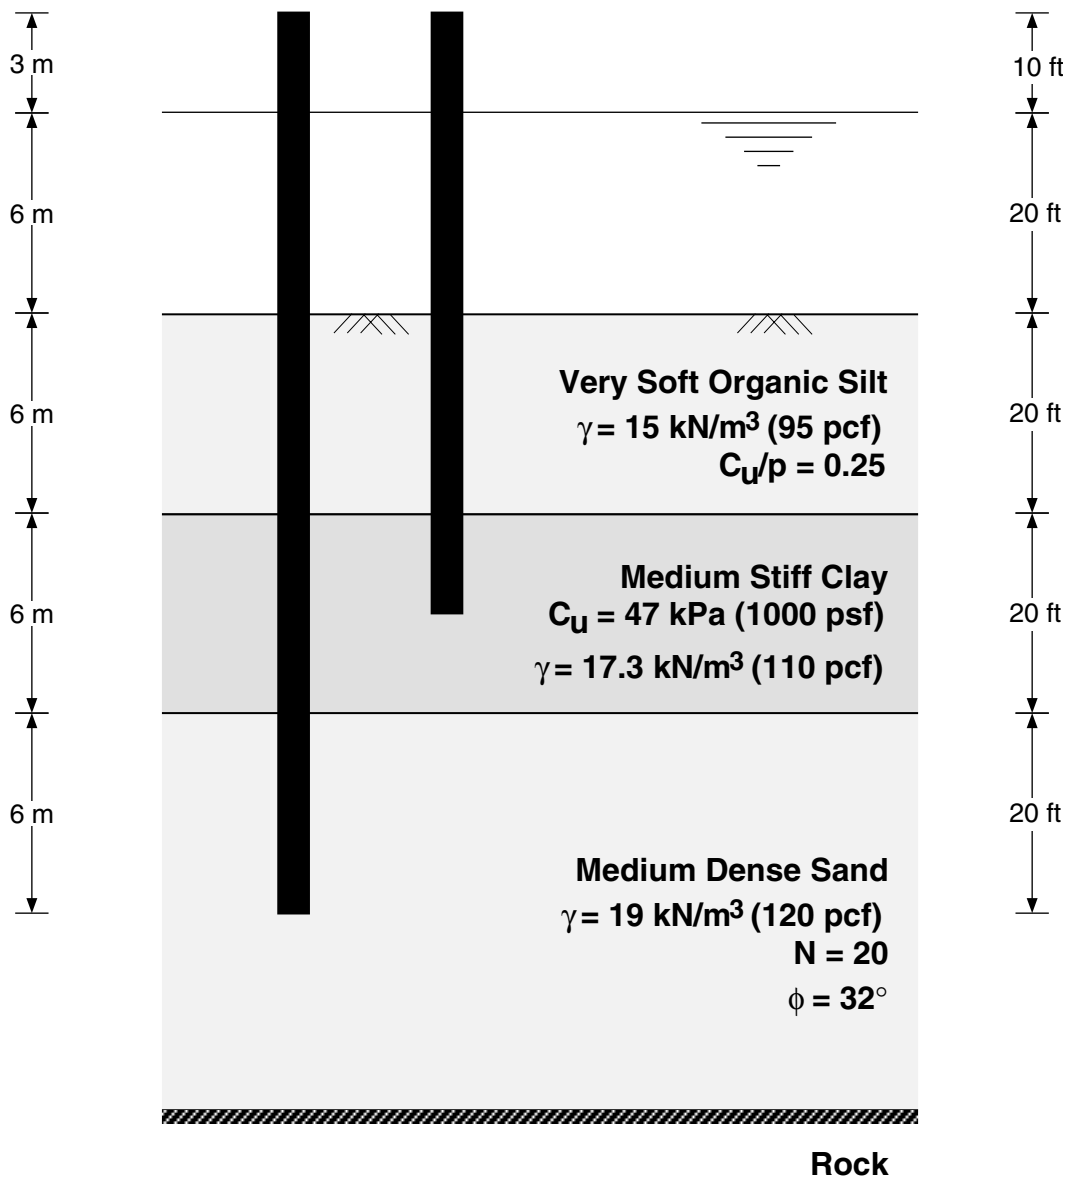
**Fig. 11 Typical Manhattan Waterfront Soil Profile**

The feasibility of driving FRP composite piling was studied for the typical water front site shown in Fig. 11. The soil properties indicated in Fig. 11 are typical of those properties supporting many of the New York harbor piers. Older piers are supported using timber piling. Because of marine borers' attack, new structures are supported on higher capacity piles made of steel and concrete, which allow for longer deck span distances. Nevertheless, low capacity piles are still widely used as fenders to protect piers from ship impact. Two pile capacities were selected to accommodate the range of pile capacities being used in the New York waterfront.

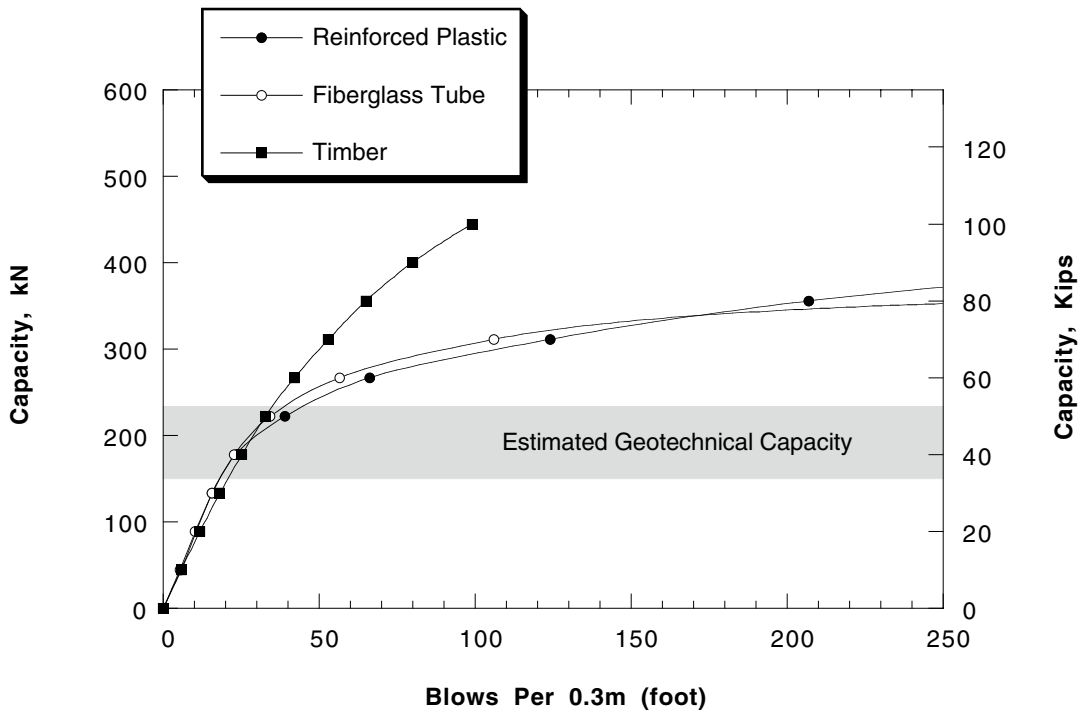
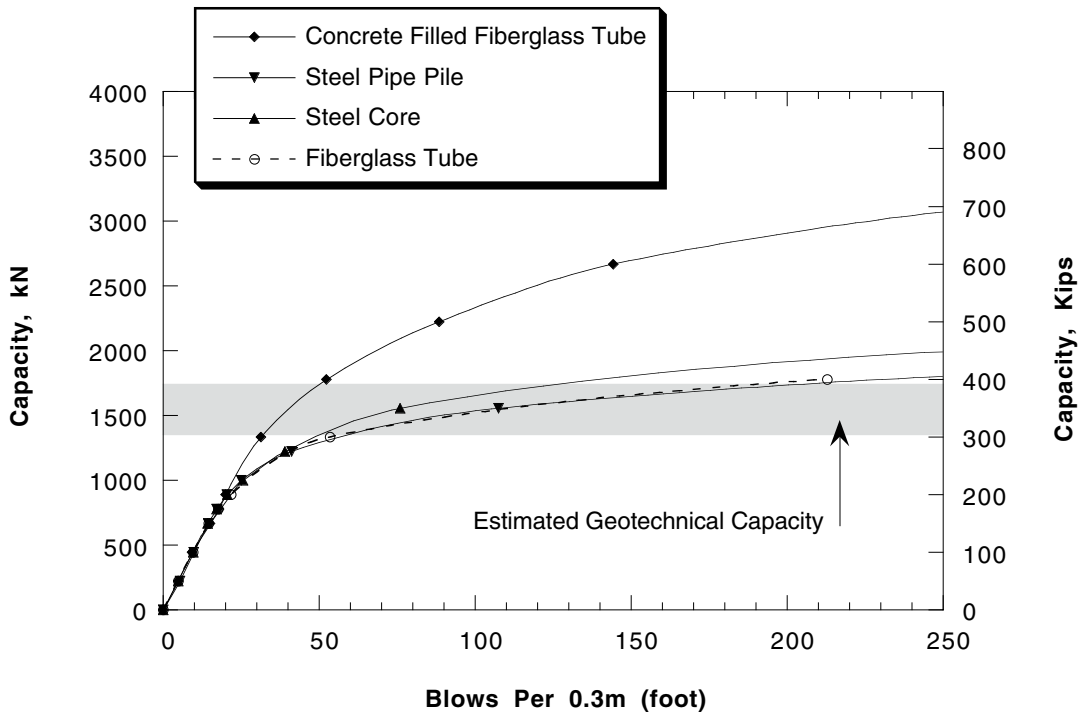
**Fig. 12 Theoretical Bearing Graphs for (1) Low Capacity Short Piles (21 tons) and (2) High Capacity Long Piles (170 tons)**

The bearing curves of piles analyzed using single acting VULCAN 02 hammer having a rated energy of 9.85 kJ (7.26 kip-ft) are shown in Fig. 12a. All three piles were reasonably efficient to drive at the estimated geotechnical capacity. Timber is more efficient to drive at higher capacities. The fiberglass pile is stiffer than the reinforced polymer piling. However, the

The bearing curves of piles analyzed using single acting VULCAN 10 hammer having a rated energy of 44 kJ (32.5 kip-ft) are shown in Fig. 12b. All four piles were reasonably efficient to drive at the estimated geotechnical capacity. The steel pipe, steel core, and fiberglass pipe piling drove similarly. Concrete filled fiberglass, which is the heaviest and stiffest, was the easiest to drive. Tensile stresses on the order of 14 MPa (2 Ksi) were calculated in the concrete filled fiberglass piling during easy driving. Similar values were also measured by Chernauskas and Paikowsky (27). The tensile stresses in fiberglass piling was close to the ultimate strength, which is a cause for concern due to the lack of data on the performance of fiberglass under impact driving.
