NDT Prediction Symposium at UMASS/NGES

Summary

This paper presents the results of a blind prediction symposium of construction defects in drilled shafts. Six drilled shafts were constructed, at the National Geotechnical Experimentation Site in Amherst, Massachusetts. Several types of defects were integrated into the shafts including necking, voids, caving, and soft bottoms. Nine organizations participated in a blind defect prediction symposium, using a variety of NDT techniques including both down-hole techniques such as crosshole sonic logging, single-hole sonic logging, and cross-hole tomography and surface techniques such as pulse echo and sonic mobility. Most participants found defects that were larger than 10% of the cross sectional area. However, false-positives and inability to locate smaller defects and multiple defects in the same shaft were encountered.

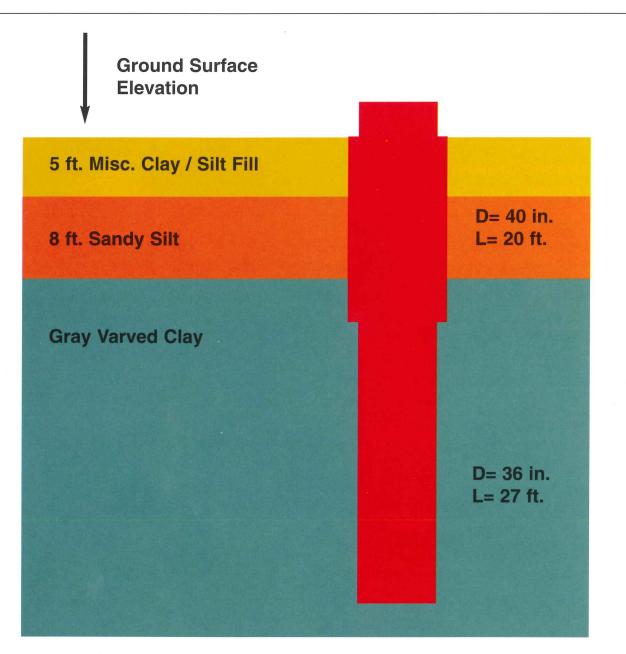
Figure 1 Shaft & Soil Profile

the UMASS-NGES using a Soilmec R-515 hydraulic rotary drill rig, and a Champion 36 rock auger. The subsurface conditions are shown in Figure 1. To facilitate construction, a 900 mm (36 in) diameter hole was augured to a depth of approximately 6 m (20 ft). A 1 m (40 in) outer diameter temporary casing was inserted in the augured hole. Next, a 900 mm (36 in) diameter hole was

augured through the casing to a final depth of 14.3 m (47 ft) below grade. Below the casing, shafts were drilled open hole without the use of slurry. The hole remained open for several hours without the accumulation of more than 50 mm (2 in) of water prior to pouring concrete. The shaft bottoms were sounded prior to concrete placement.

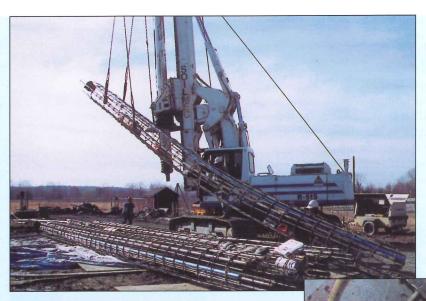
Cage to be placed in Test Shaft.

Downhole view of "defect.

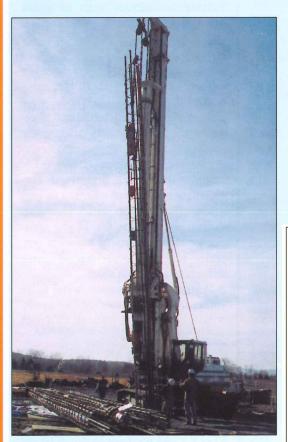
Rig leads cage for placement.
