# Root Growth of Accolade™ Elm in Structural Soil Under Porous and Nonporous Asphalt After Twelve Years

By Nina Bassuk, Gary Raffel, and Miles Schwartz Sax

**Abstract.** Accolade™ Elm trees were planted in CU Structural Soil® overlaid with porous or nonporous asphalt in 2005. At three separate points (2012, 2015, and 2016) over the last twelve years, root densities were measured with Ground Penetrating Radar to a depth of 30 inches (76.2 cm) beneath the asphalt. Roots under the porous asphalt were more numerous and tended to grow deeper in the structural soil profile. Shoot growth was reduced in trees that grew under the nonporous asphalt beginning in the eighth year after planting. CU Structural Soil® is a viable medium for tree growth and stormwater capture when paved with porous asphalt.

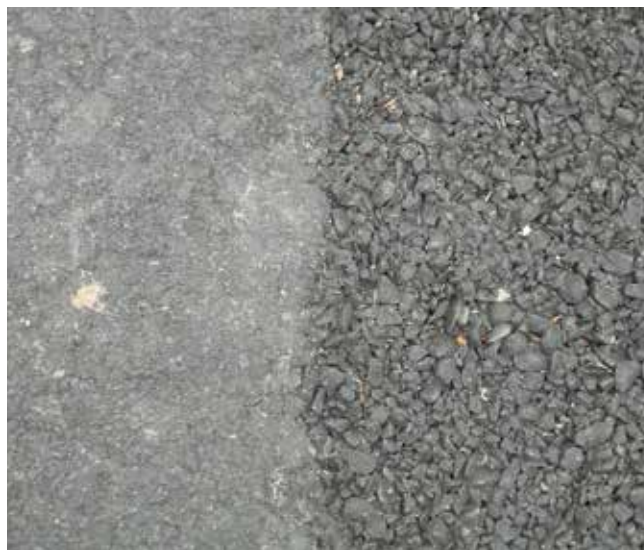
**Figure 1. Interface between the nonporous (left) and porous (right) pavement in the parking lot installation.**

In the middle of each pavement profile type (porous or nonporous asphalt), 3-ft (0.914-m) wide tree pits were cut, running the entire 18-ft (5.49-m) width of the lot to the shoulder of the adjacent roadway. Within each tree pit, two bare-root 1.5-in (3.81-cm) caliper Accolade™ Elms (*Ulmus davidiana* var. *japonica* 'Morton,' ACCOLADE™ Elm) were installed (Figure 2). Eight other Accolade™ Elms of the same size were planted within a 2-ft (0.46-m) adjacency surrounding the parking lot with four of these adjacent to the porous asphalt profile and four of these adjacent to the traditional asphalt profile (Figure 3). Due to the constraints of installing these contrasting pavement

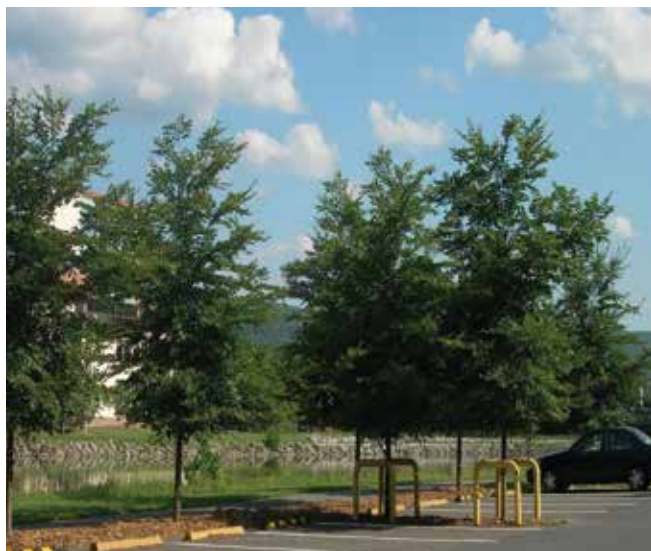
**Figure 2.** Parking lot design showing Accolade™ Elms planted in asphalt cutouts four years after installation. Trees are growing in a CU-Structural Soil® base with either nonporous or porous pavement on top.

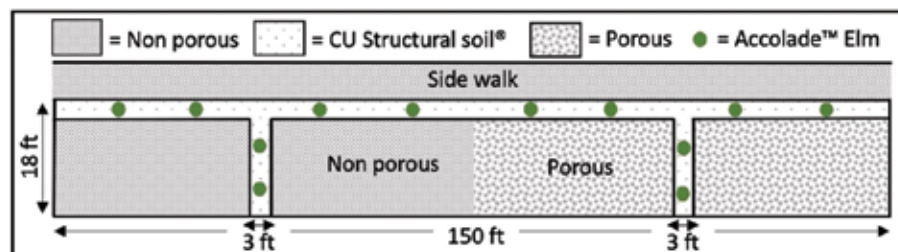
**Figure 3.** Diagram of the parking lot design showing nonporous and porous pavement over CU-Structural Soil®. Structural soil functioned as a base for pavement and as a planting substrate for Accolade™ Elms. Elms were planted directly into structural soil in pavement cutouts and mulched in after installation.

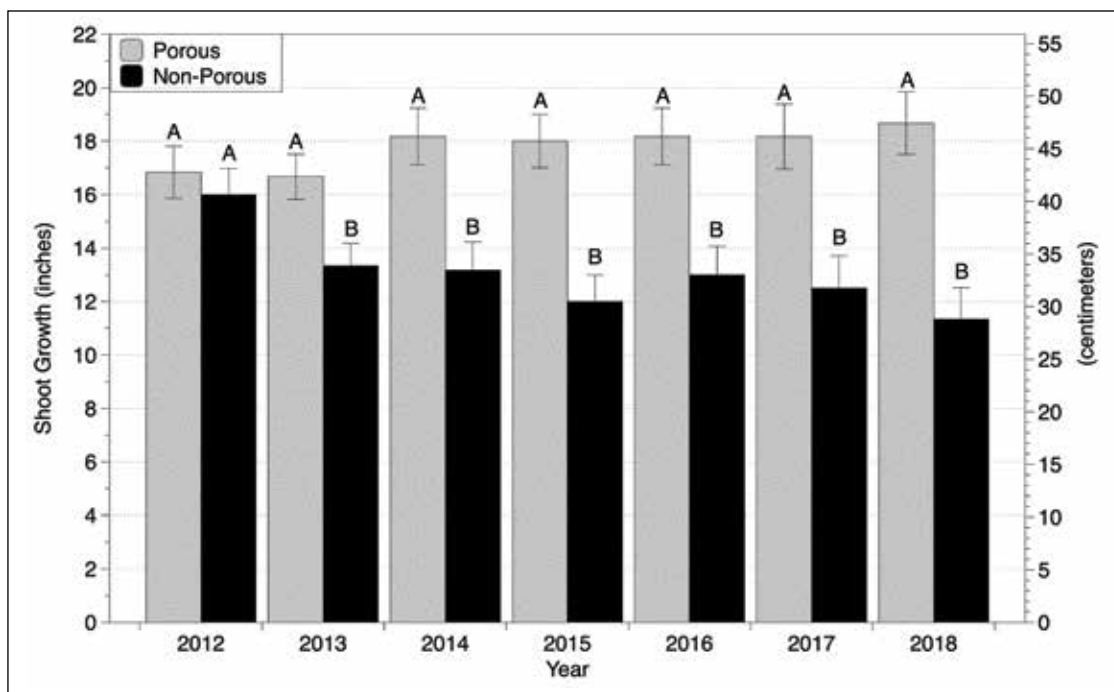
**Figure 4. Yearly shoot growth (inches) of Accolade™ Elms grown in porous and nonporous paving between 2012 and 2018 ( $n = 6$  per treatment). Matching letters indicate difference by treatment (porous vs. nonporous) for individual years.**

Shoot growth for Accolade™ Elms was equal under porous or nonporous asphalt until 2013, at which time growth of trees in nonporous pavement began to slow down. During 2012 to 2018, shoot growth for trees in porous asphalt was equal between years, while shoot growth for trees in nonporous asphalt declined (Figure 4; Table 2). Root density during year 2012 was nearly equal under porous and nonporous pavement except for roots in the deepest layer of structural soil (16 to 30 in) which grew deeper and showed a density 70% greater than roots under nonporous pavement (Figure 5). In 2015 and 2016, roots were consistently more numerous under porous asphalt than those under nonporous asphalt, especially in the middle and deep layers of the profile (8 to 16 in and 16 to 30 in respectively), showing about 50% greater root density on the 8 to 16 inch profile and 70% greater root density in the lowest profile (Figure 5). For all three years (2012, 2015, 2016) that root density measurements were taken, statistically significant differences were observed for pavement (A. porous vs. nonporous), sampling depth (B. 0 to 8 in, 8 to 16 in, 16 to 30 in), and their interaction (A × B) below a 0.05 alpha

Terminal shoot length began to decline after the sixth year of trees growing under nonporous asphalt compared to those growing under porous asphalt (Figure 4). Although

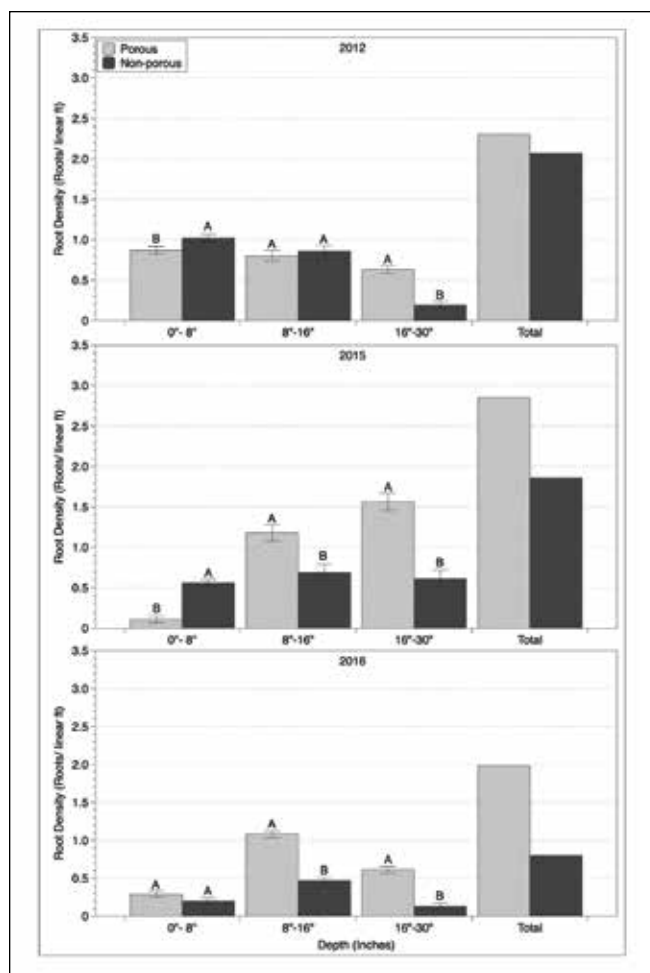
**Figure 5.** Root density per linear foot of Accolade™ Elm (*Ulmus davidiana* var. *japonica* 'Morton') at three depths in porous and nonporous pavement in 2012, 2015, and 2016. Matching letters indicate difference by treatment (porous vs. nonporous) for each depth category.

it was not possible to measure soil moisture under the two pavements, root growth density per linear foot was greater in trees under porous asphalt, likely allowing for greater water uptake and shoot growth. It is possible that, had the opening around the trees in nonporous asphalt been greater, adequate water might have been available. Both growing media were identical in this study, with similar available water-holding capacity ranges suggesting that the quantity of water entering the system was the likely limiting factor.
